### Solution Architecture – 3D SPI Closed Loop

### Industrial Use in Marelli SMT Line

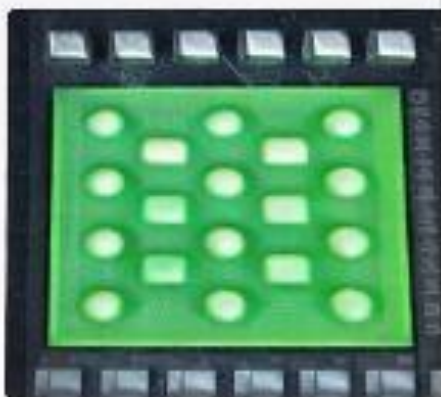
- 60–80% SMT defects originate in solder paste printing:
- Process instability causes:
- Insufficient / excess paste
- bridging between pads
- paste misalignment
- Traditional 2D inspection is insufficient for fine-pitch components

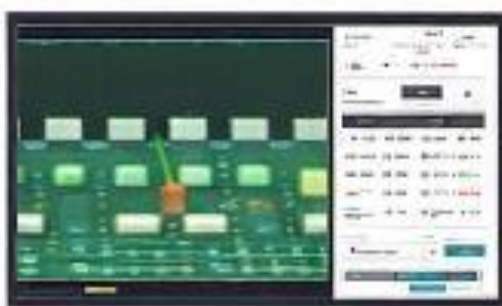
### Solution Architecture – 3D SPI Closed Loop

- Implemented on Marelli SMT production line.
- 3D SPI placed directly after stencil printer.
- Real-time evaluation of each PCB panel
- Automatic printer feedback (closed-loop control)
- Operator supervision and MES data logging

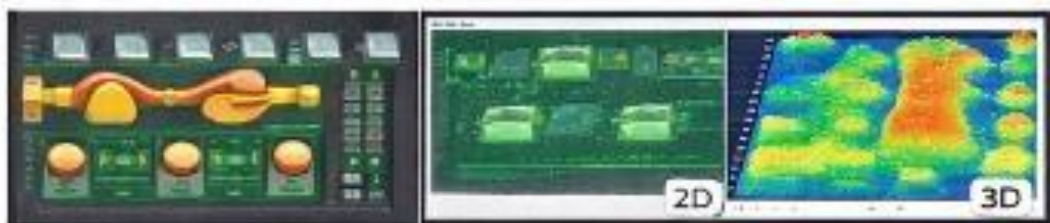
Detected bridging defect by SPI system
